School Route Audit Report

St Luke & St Philip's Church of England Primary School, Blackburn

15TH March 2024

Compiled by Daniel O'Connell, Project Coordinator

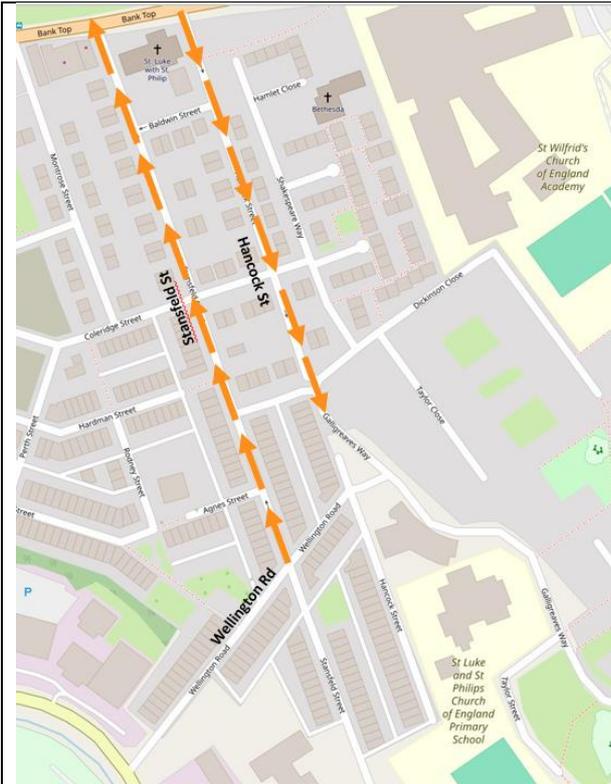
Recent completion of housing developments along Stansfeld Street and Hancock St (to the north of Wellington Road – see image **a**) have seen a change in road priority and incorporation of a one-way system, allowing space for pavement buildouts and on-road parking bays to be created (image **b**). This was noted as having a huge improvement in reducing / eliminating pavement parking along these streets.

Left: Image (a) Showing change in road priority and one-way system established along Stansfeld St and Hancock St.

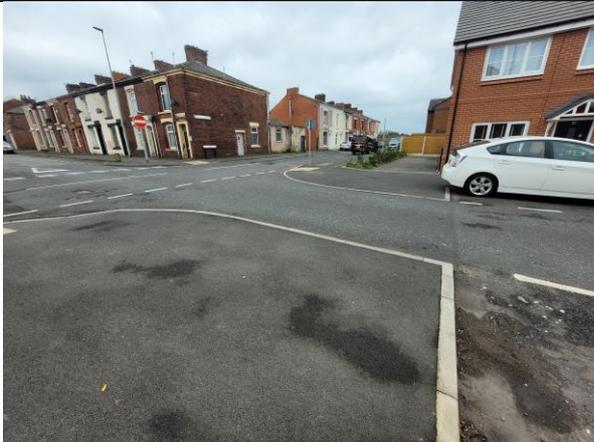
Left: (Image b) – view along Stansfeld St, showing parking bays and pavement buildouts.

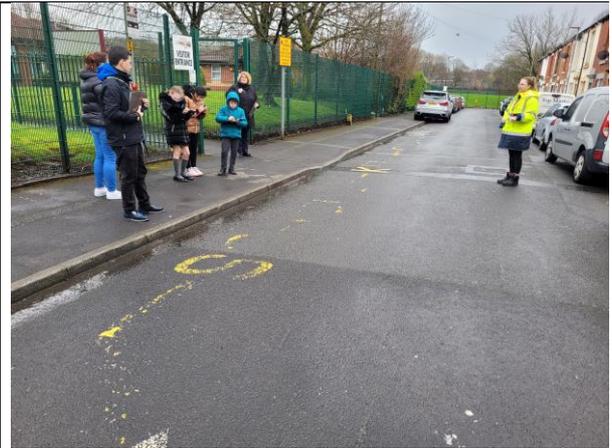
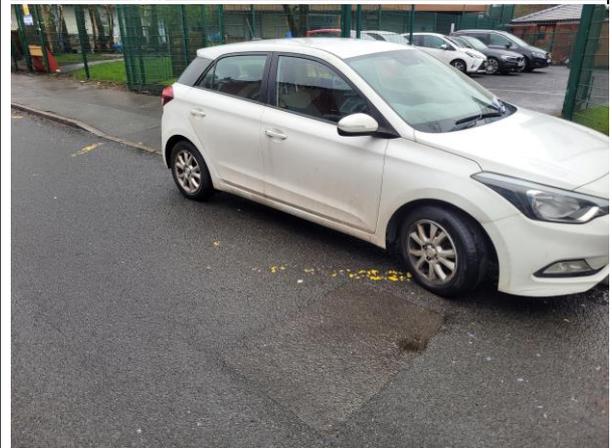
Hancock Street is the main access point to the school's ground. The audit group explained the problems of heavy congestion along this section of road, with vehicles parking on both sides of the road, mounting pavements and blocking gates during drop-off/pick-up times. Pavement parking and parking over the faded yellow zig-zag lineage was observed.

Above: Hancock Street – faded yellow zig-zag lineage and cars ignoring markings and parking over them.

- Complete repaint of yellow lineage along Hancock Street
- Traffic enforcement officers to have a scheduled presence in the area at drop-off/pick-up times.
- Reinforce messaging about parking alternatives – Park & Stride at Go Outdoors (or on car park off Wellington Rd) – as promoted by the WOW programme.

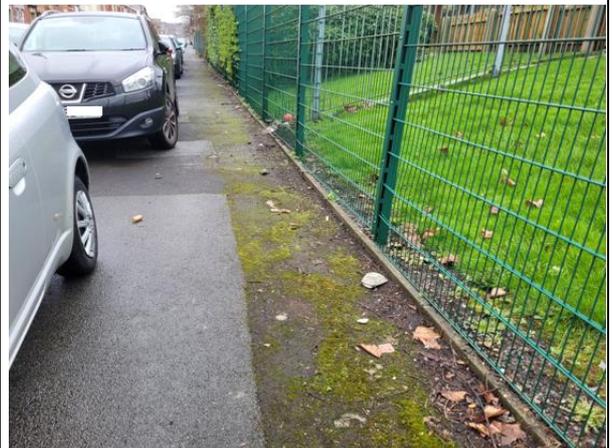
Below: Hancock Street – pavement parking

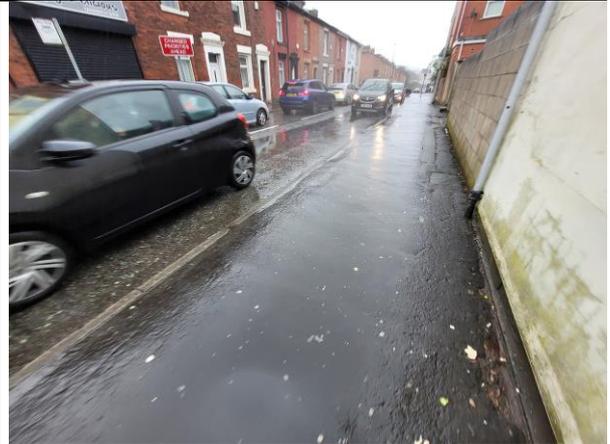
Wellington Road was reported as being heavily congested and dangerous to cross during rush hour. Participants reported that it's common for cars to speed along this road as it's the main cut-through route from Galligreaves to the B6447 (Stancliffe St). The congestion is often compounded by cars parking on the pavement and "abandoning their vehicles" on the corner with Hancock Street, outside The Wellington Chip Shop, which was noted as a particularly difficult corner to cross during times of peak traffic flow. Many families walking to school (or to the adjacent Children's Centre) have to navigate this Wellington Rd/Hancock St junction and report it as feeling unsafe and in need of a dedicated safe crossing point for pedestrians.

Above: Congestion along Wellington Road during the morning's school run.

- Traffic calming options to be explored to address issues of speeding vehicles along Wellington Road.
- Options for a safe crossing point across Wellington Road towards Hancock Street to be explored, along with options for support from a School Crossing Patrol Officer.
- BwD Highways Department to address the issue of blocked drainage and gully flooding issue.

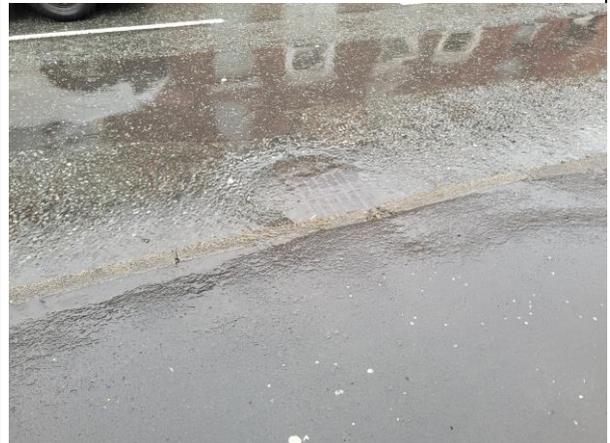
Pupils also noted the blocked drainage and resulting highway flooding issue on Wellington Road.

Below Drainage blocked on Wellington Road causing pooling of water. <https://what3words.com/hung.truly.truly>

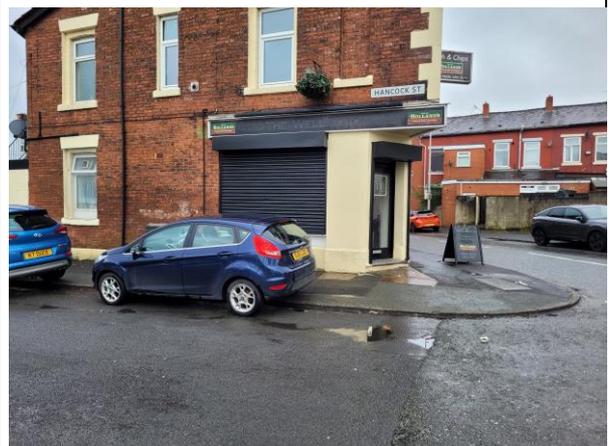
Below: reported issues of cars parking on the corner around The Wellington Chip Shop, blocking pavements and causing issues to traffic flow.

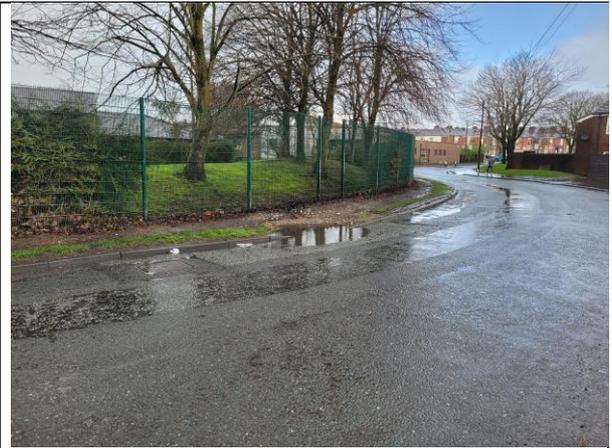
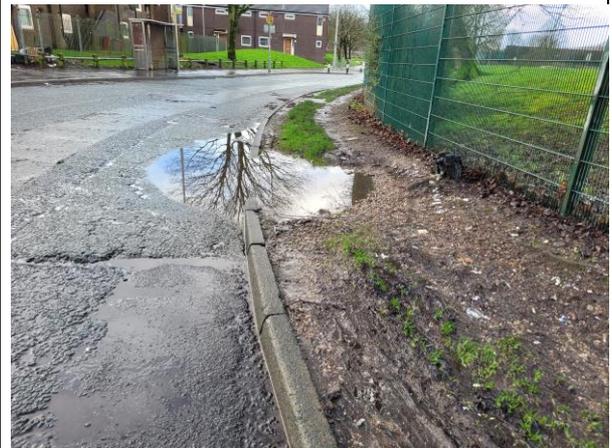
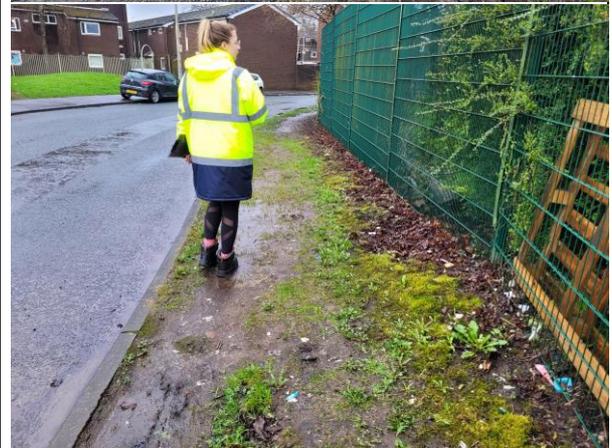
The pavement along the west of Galligreaves Way, running alongside the perimeter of the school's grounds, was in a particularly bad state of repair. It was impassable by foot, unsurfaced and presented a flooded, muddy, slippery obstacle rather than an accessible footway.

Above: Images showing the section of pavement along Galligreaves Way to the side of the Primary School / Children's Centre. Surfacing is absent and evidence of car tracks and flooding. From: <https://what3words.com/spared.worker.hangs> to <https://what3words.com/sounds.monks.suffer>

- Highways Department to conduct a site visit and propose remedial action to address the surfacing and accessibility issues along this section of the pavement.

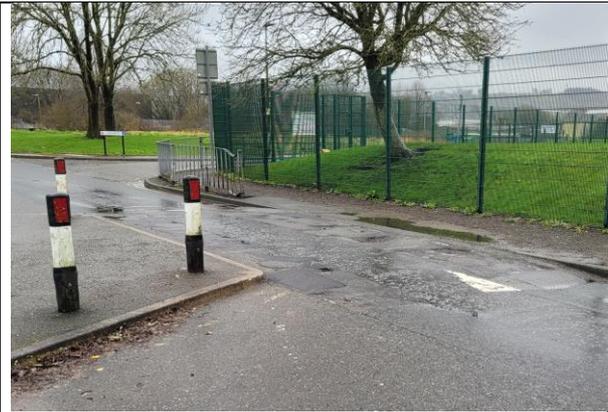
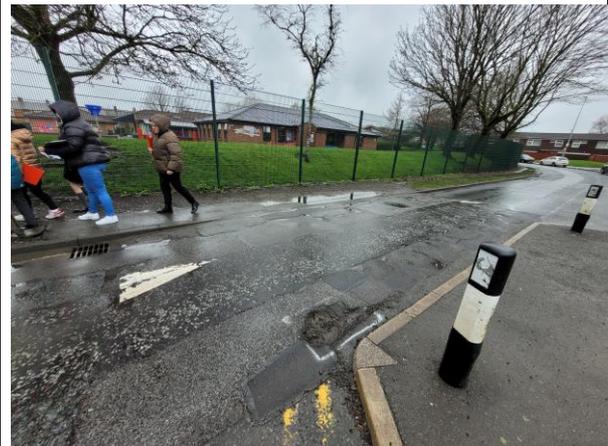
There was also concern that the raised table merged with the pavement level (on the school's side of the street) and there was little to distinguish between road and pavement at this point, as such cars frequently mount and drive along the pavement when navigating over this raised table. Evidence of a collision with the railings could be seen here too. Flooding of the footway was also observed.

Above: Common crossing point of Galligreaves Way at the chicane built out / raised table.

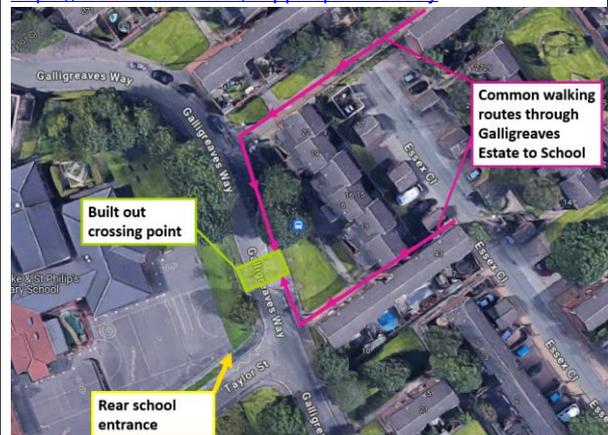
Above: Figure 1 - Annotated map showing area of concern

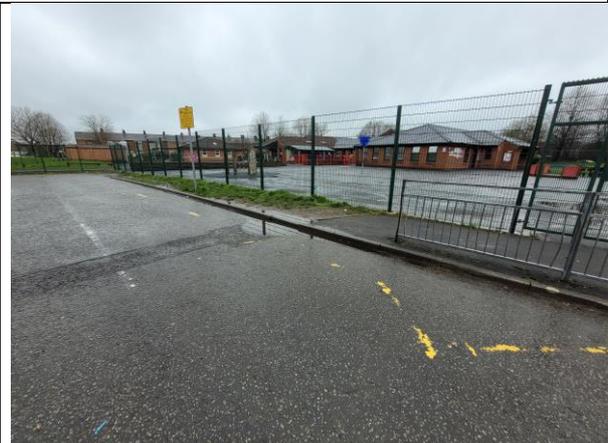
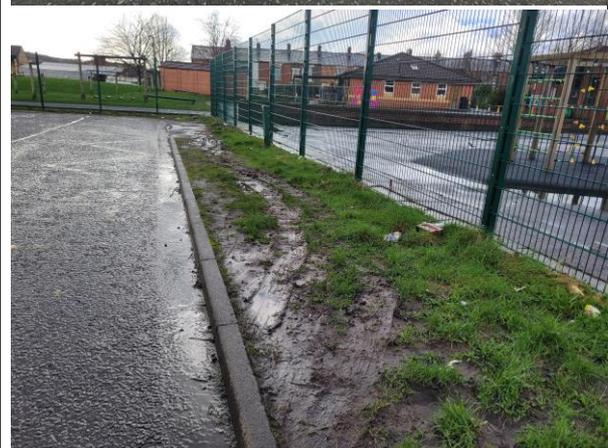
Above: View along Taylor Street looking west from Galligreaves Way. The rear school entrance is to the right on the photos. From <https://what3words.com/quick.carbon.join> to <https://what3words.com/being.design.hurray>

- Long term: Permanently close the road to vehicle access (this will help address points 6 and 7 that follow). It is understood that previous discussions within the council to block Taylor St to vehicle access have been raised, but due to school traffic using

this as a drop-off/pick-up point and fear that blocking this road will displace said traffic onto an already busy Galligreaves Way, this option has not previously been explored further. However, with this school now running the WOW Walk-to-School Programme, along with promotion of Park & Stride options, in addition to post-code plotting data highlighting 79% of school children live within an easy walkable distance, the option to redesign this road and block vehicle access should be revisited.

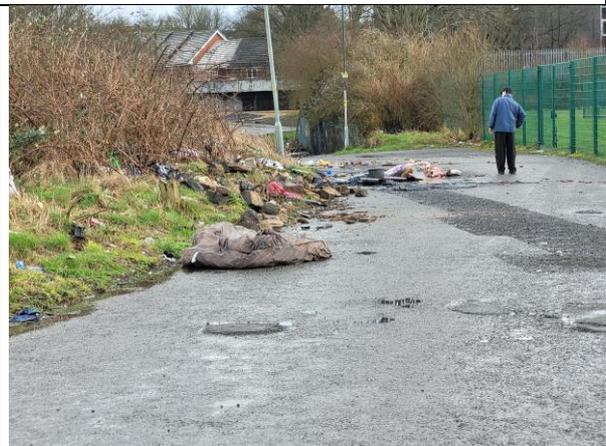
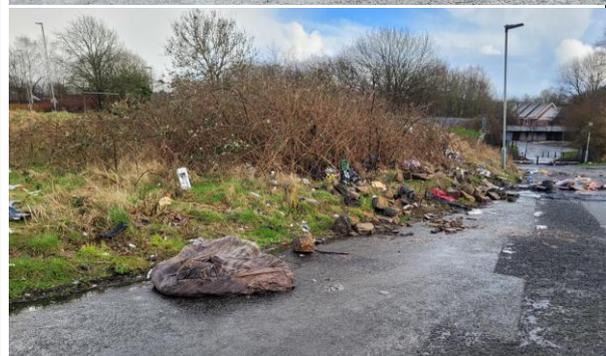
Above: Taylor Streets looking south towards the Railway Bridge with the school's grounds to the right of the photo. From <https://what3words.com/delay.with.reject> to <https://what3words.com/called.loved.globe>

- Long term: as with point 5 above, permanently close Taylor St to vehicle

access and look to re-design layout to encourage walking and cycling.

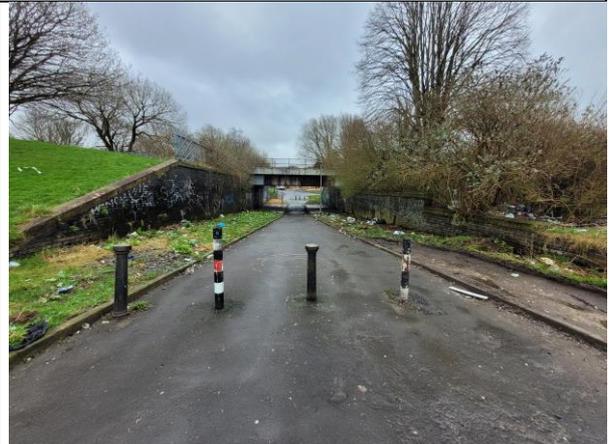
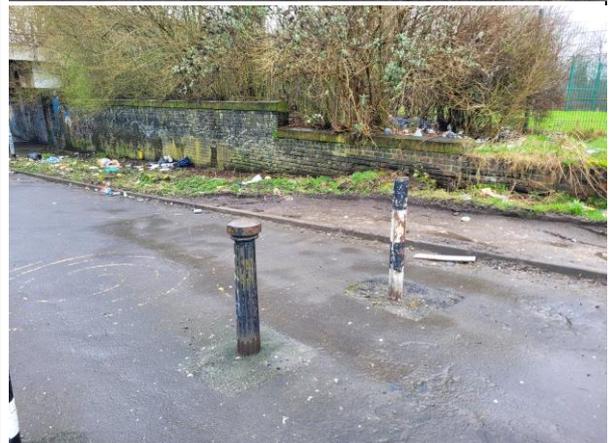
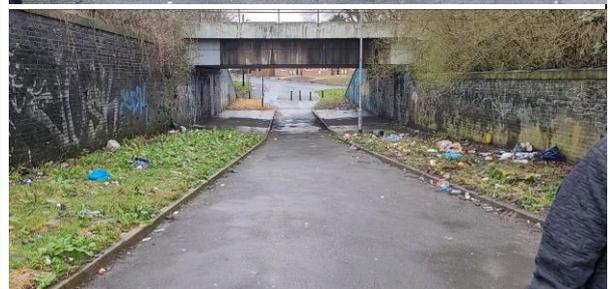
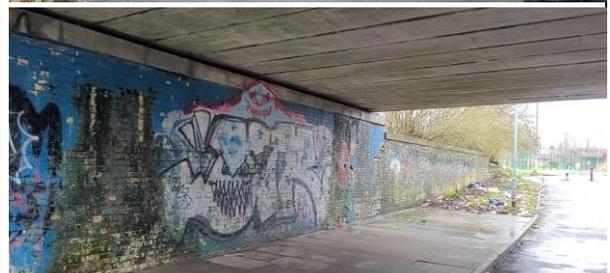
- No lighting in tunnel – Parent referring to railway underpass on Taylor Street
- One Parent has to pick her daughter up as she is scared of the rats – Parent talking about walking through the railway underpass on Taylor Street

- Some families will not walk through the tunnel and will go the long way around because it's so disgusting – Parent

Above: Views looking south along Taylor Street, under the

- Long term:
Permanent closure of Taylor St to vehicles to be explored, with options to redesign this route into one that promotes walking & cycling and encourages children to want to walk to school.
- Short term:
Replace bollards to fully close this section as intended on both sides of the railway bridge.
Deep clean of the area under the railway bridge / address vermin issue.
Repaint / mural the walls to cover the

<p>graffiti (have pupil involvement in mural creation) and improve the look and feel.</p> <p>Installation of lights under the bridge that fully illuminate the underpass.</p>	<p>railway bridge and out towards Lower Hollin Bank St in the distance. From https://what3words.com/called.loved.globe to https://what3words.com/glee.barn.bless</p>
<p>8 – Children’s Play Area between Galligreaves Way & Taylor Street</p> <p>The audit group observed that the children’s play area between Galligreaves Way and Taylor Street was in a state of decay, with aspects of the play area having been removed/dismantled (swings). It was felt by the group that this play area was in a slightly secluded location, tucked away in a corner, and didn’t feel a particularly safe place for children to play. Pupils in the audit group said, “we don’t play here anymore” and prefer the “new play area in the estate” (see point 9). Evidence of discarded alcoholic drink bottles and cans suggested the area may now attract anti-social behaviour.</p> <p><u>Recommendations</u></p> <ul style="list-style-type: none"> - Explore options to re-purpose/redesign this area in consultation with the local community.

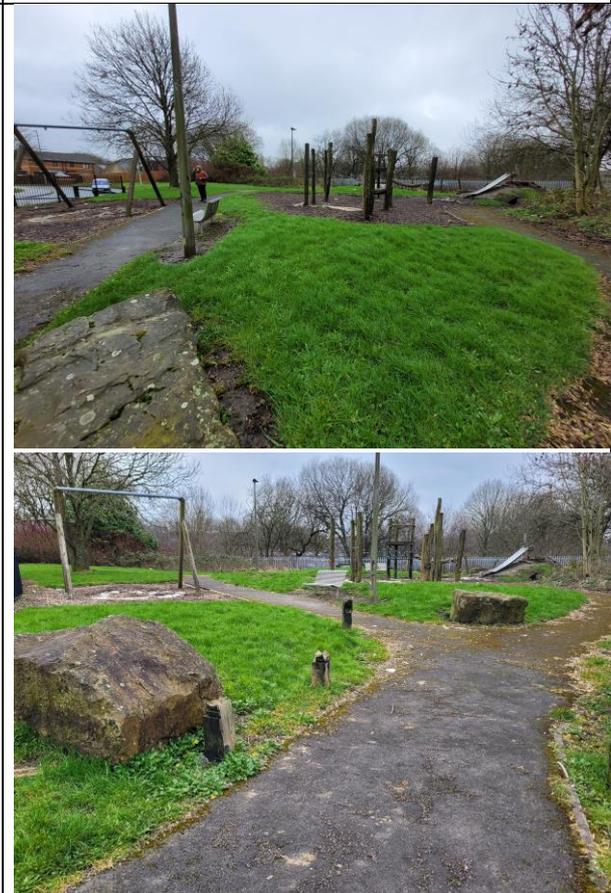
<p>Above: Views of children’s play area. https://what3words.com/river.coach.tried</p>

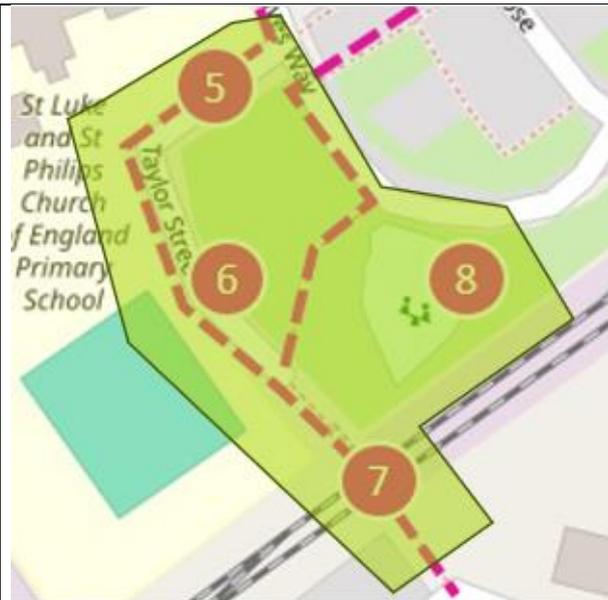
Above: **Figure 2** – Taylor Street and surrounding green space

- Taylor St, from Galligreaves Way to under the railway bridge and onto Lower Hollin Bank St (points 5 to 7), presents a range of issues from congestions to fly-tipping to infestations. Access to Taylor St at point 7 is currently blocked to vehicles (or is intended to be) by use of bollards at either side of the underpass, that don't quite serve their intended purpose. Taylor St serves no purpose to vehicles other than as a drop-off/pick-up point for school traffic (as discussed in point 5) and as an apparent access point for fly-tipping. Serious consideration should be given to the redevelopment of Taylor St to provide a safe and pleasant pedestrian / cycle only route – from Lower Hollin Bank St, under the railway bridge and along Taylor St to the rear school entrance and onto Galligreaves Way. A route attractive to families and children that encourages active travel to school. Scope to redevelop the area including the

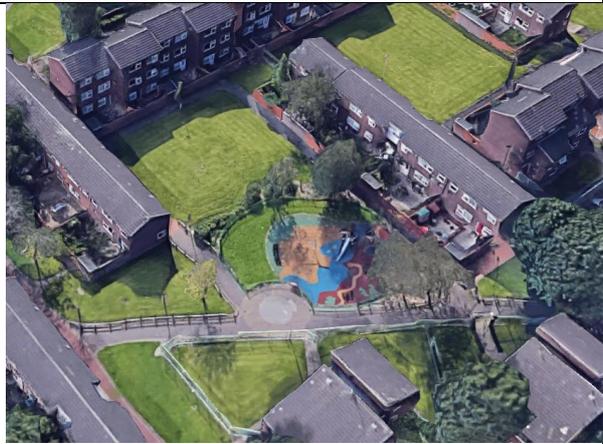
<p>Imagery © 2024 Google. Bluesky and Infoterra Above: View of newly created children’s play area in the centre of Galligreaves Estate. https://what3words.com/spun.belts.dips</p>
